**0016** Technical Service Information**Subject:** Integrated rotary shaft seals**Relates to:** 81-90006-00  
81-90010-00  
81-90016-00  
81-90018-00**Make:** Volkswagen, Audi, Seat, Skoda**Model(s):** Various**Engine code:** Various**Integrated rotary shaft seal -  
installation information**

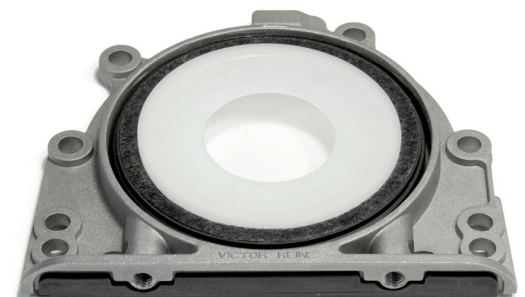
Figure 2\_Underside of the integrated rotary shaft seal

The rubber coating underneath the integrated rotary shaft seals has no sealing function [Fig. 2]. For this reason, the application of additional sealing compound or a corresponding oil sump gasket is necessary during replacement.

This means that the oil sump always needs to be detached and newly re-sealed whenever the integrated rotary shaft seals are replaced.
